Environmental Monitoring Report

Semi-Annual Environmental Monitoring Report (January – June 2017)
September 2017

VIE: Ha Noi Metro Rail System Project (Line 3: Nhon – Ha Noi Station Section)

Prepared by Ha Noi Metropolitan Railway Management Board for Ha Noi People's Committee and the Asian Development Bank.

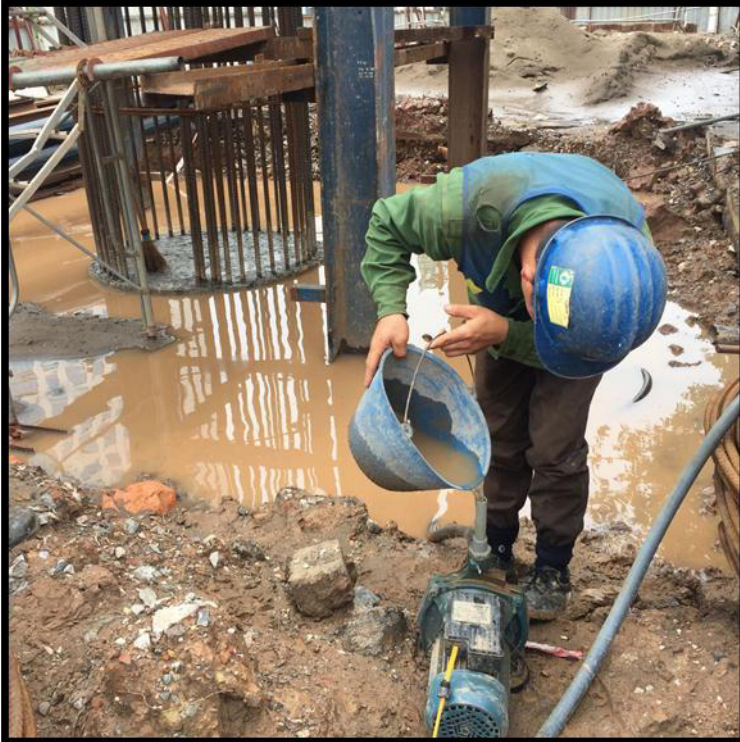
| Issues/Concerns/Findings | Pictures |
|--|--|
| <p>Issue: Wastewater management</p> <p>Description: After rains, excavated holes at sites were flooded and the contractor needed to pump water out that overflowed on the road surface before flowing into manholes.</p> <p>Location: Construction site of P 368 to P 375</p> <p>Time: June 2017</p> | |

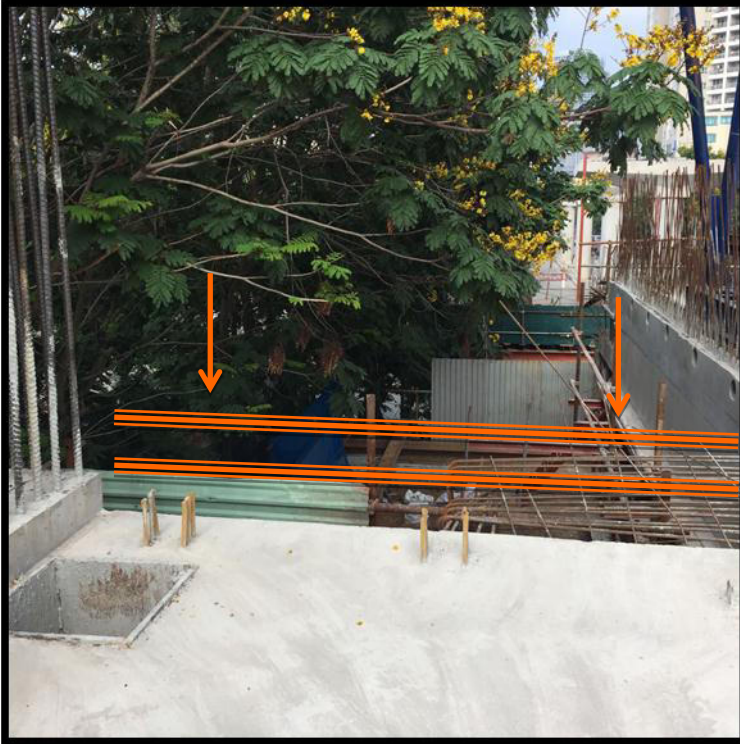
| Issues/Concerns/Findings | Pictures |
|--|--|
| <p>Issue: Risk to construction safety</p> <p>Description: construction site at height was not secured by rail hand guard or proper fences.</p> <p>Location: at the site for station number 6</p> <p>Time: May 2017</p> | |

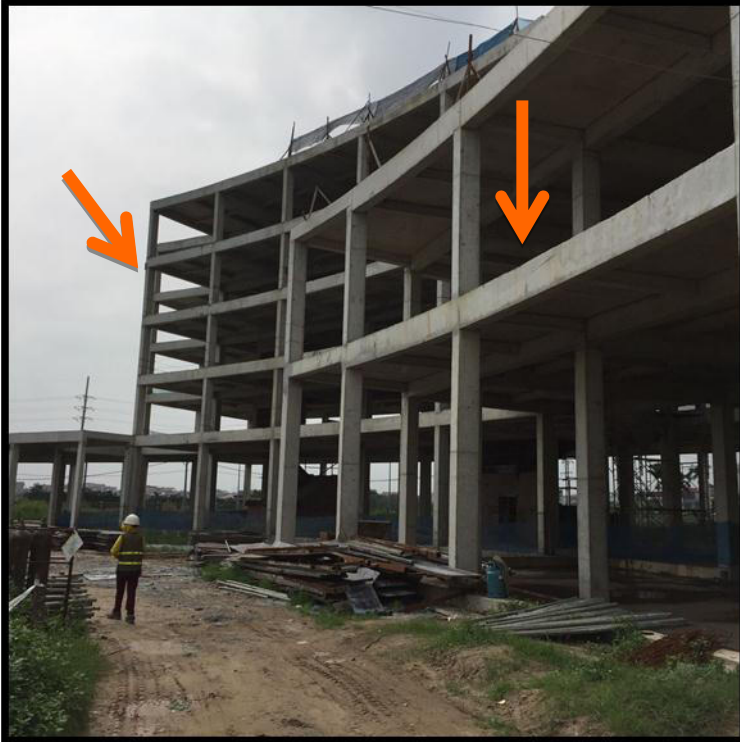
| <p>Issue: Risk to construction safety</p> <p>Description: construction site at height was not secured by rail hand guard or proper fences.</p> <p>Location: at the site for OCC building at the Depot</p> <p>Time: June 2017</p> | |

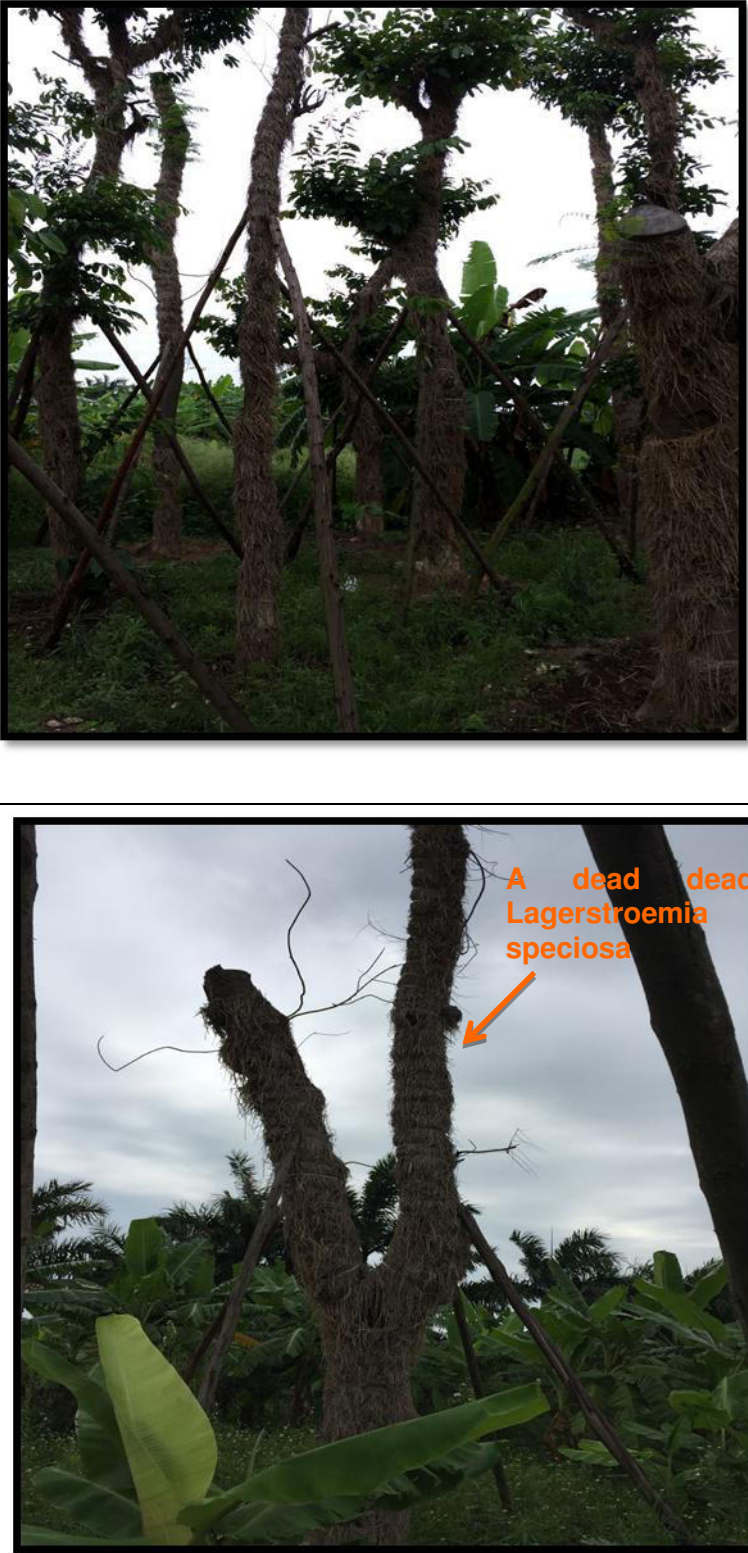
| Issues/Concerns/Findings | Pictures |
|---|--|
| <p>Issue: Tree relocation</p> <p>Description: In September 2016, 107 trees located in the corridor alongside the ramp to station 8 were relocated to a nursery garden with an area of 3ha in Dong Du Commune, Gia Lam District, Ha Noi. The survival rate of trees up to June 2017 is 91,6%, as 9 of 107 trees were dead.</p> <p>The nine dead trees are a mango tree, a <i>Khaya senegalensis</i>, a Phoenix, a <i>Cassia siamea</i> and five <i>Lagerstroemia speciosa</i>. Most dead trees are <i>Lagerstroemia speciosa</i> that have thinner tree skins than other trees. The contractor (Beepro) concluded that given thinner tree skin, these trees could not survive during winter after being trimmed and unrooted during relocation. The rate (90%) of dead <i>Lagerstroemia speciosa</i> of the first tree relocation campaign is an important lesson for the next tree relocation campaigns.</p> <p>The contractor provided 8 regular workers that are adequately trained to nurse and guard the relocated trees at the garden.</p> <p>98 relocated trees that still have young leaves growing up and developing, are still planned to be nursed at the garden at least one more year. But it remains unclear where these trees will be eventually relocated, and how the trees will cope with a second relocation.</p> <p>Location: at the garden in Dong Du commune, Gia Lam District, Ha Noi</p> <p>Time: May 2017</p> | <p>The top photograph shows a group of trees in a nursery garden, each supported by a wooden stake. The trees have varying trunk thicknesses and some have visible signs of being recently relocated. The bottom photograph is a close-up of a dead tree trunk, which is thin and has a rough, textured bark. An orange arrow points to the dead trunk, with the text 'A dead dead Lagerstroemia speciosa' written in orange above it.</p> |

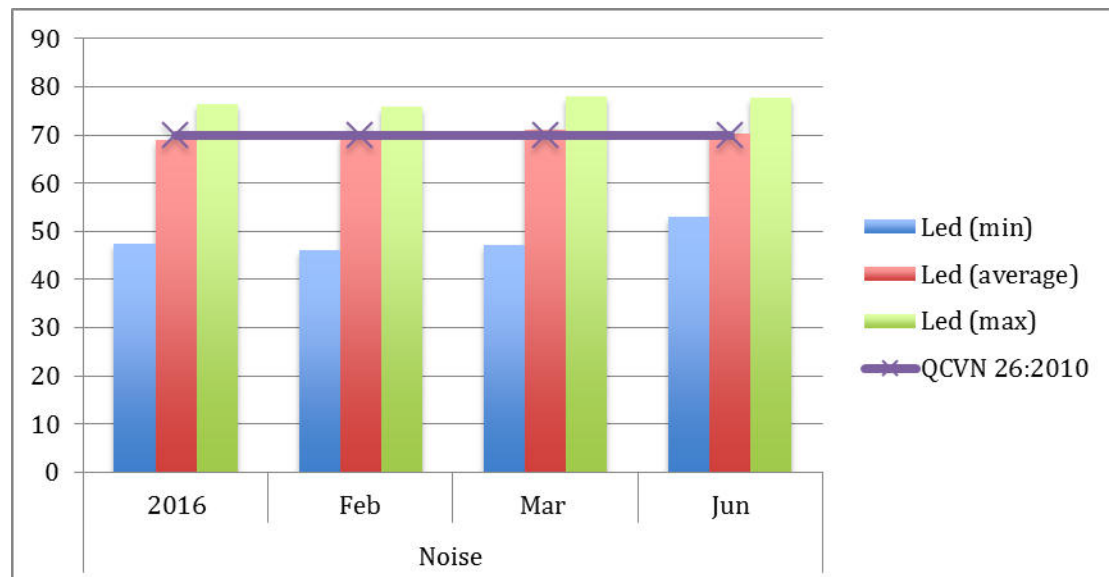
Figure 4. Noise levels measured during January to June 2017

30. Noise measurement time was from 8.00 to 22.00. All the noise monitoring results shall be compared with National Specification of Viet Nam QCVN 26: 2010 / BTNMT for common area from 6.00 to 21.00. Most of the data measured at the locations are higher than the level stipulated in the specification due to numerous vehicles on the roads. Figure 3 illustrates the results of monitoring noise level during Jan-Jun 2017 and the average results from sampling programs in 2016 (last period of report).

31. As the results from the monitoring programs during Jan- Jun 2017, the metro line can be divided in two sections, the first one from the Depot to P20 within low population density areas of Tay Tuu and Phu Dien wards, generally has noise level lower than the applied standard and the second one from P20 to the station 8, within very crowded areas, has noise level higher than the standard even during low traffic time from 6h to 7h. As a result, it is concluded that the high noise levels mostly come from public traffic rather than construction activities. The noise has not significantly changed between the noise level in 2016 and the ones in the first six months of 2017.

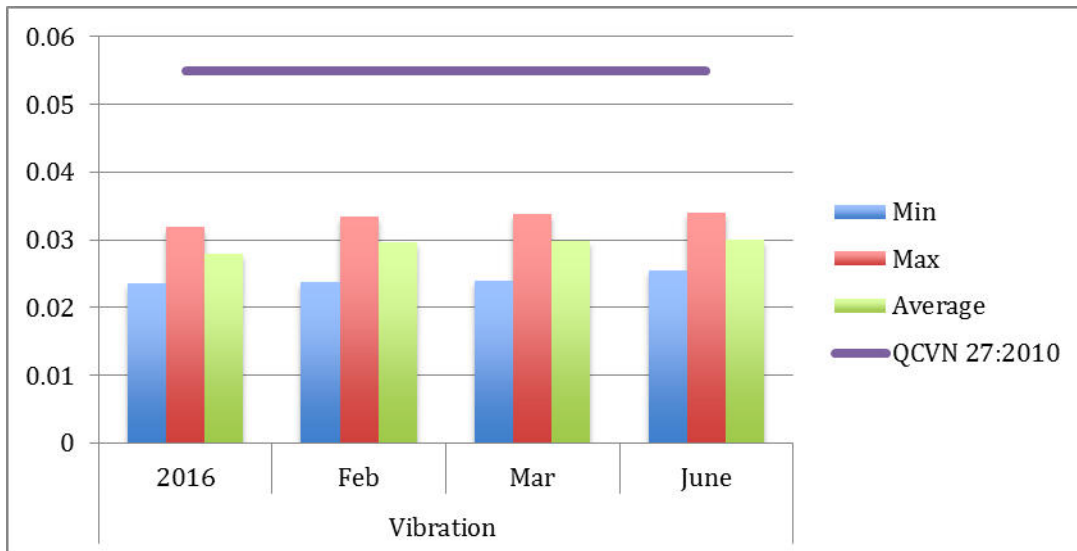
Figure 5. Vibration levels measured during Jan to Jun 2017

32. According to specifications, vibration level must not be higher than 75dB or 0.055 m/s² from 6.00 to 21.00 for common area and baseline at night. So, all the data from the monitoring programs in table 10 reveal that the maximum vibration level was lower than the level stipulated in the specification (QCVN 27:2010/BTNMT). Figure 4 illustrates the results of monitoring vibration level during Jan to Jun 2017.

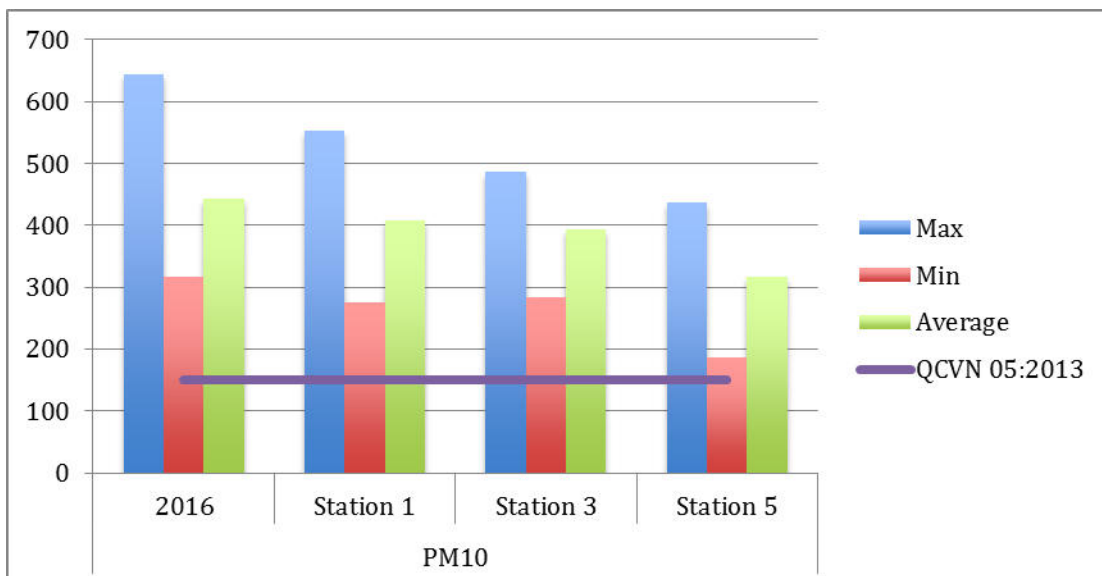
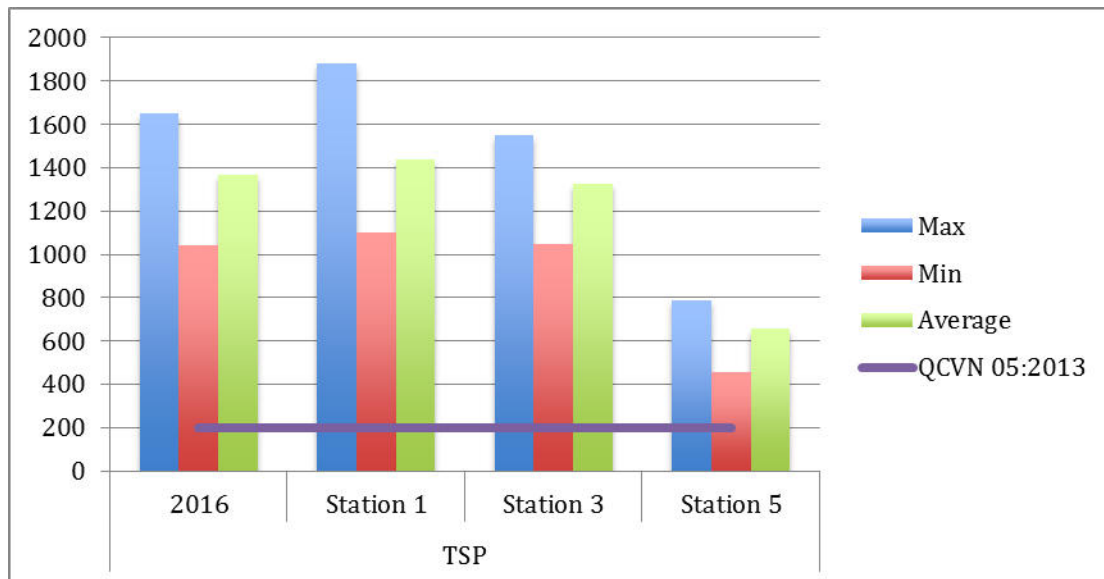
Figure 6. Concentration TSP and PM10 at three project stations

33. Only the contractor of CP02 conducted a monitoring program on dust including PM10 and TSP level for 24h. This program was carried out in June 2017 at three locations (station 1 – Nhon (Minh Khai Ward); Station 3 – Phu Dien (Phu Dien Ward) and Station 5 – Le Duc Tho station (Le Duc Tho street)). Dust measurement time was from 8.00 to 22.00. All the dust monitoring results shall be compared with National Specification of Viet Nam QCVN 05: 2013 / BTNMT. Most of the data measured at the locations are much higher (from 2.5 times to 5.5 times) than the level stipulated in the specification, but as compared with the results between June 2016 and June 2017, it is showed that the PM10 level in 2017 was slightly lower than the level in 2016, possibly due to the completion of earthworks and bored piles.

34. The most significant reason for high dust concentration is the stations to be located on the main roads (National Road 32 and Le Duc Tho streets) for material transportation to many ongoing projects in Ha Noi. The results also show the difference among three stations as the station 5 has TSP level lower than other two stations. This difference can be explained by the location of these stations; stations 1, 3 are on the material transportation routes, whereas station 5 is on an urban road with a limitation of truck during 8AM to 9PM.
